E-nose monitoring Port of Amsterdam

E-nose monitoring 2nd case

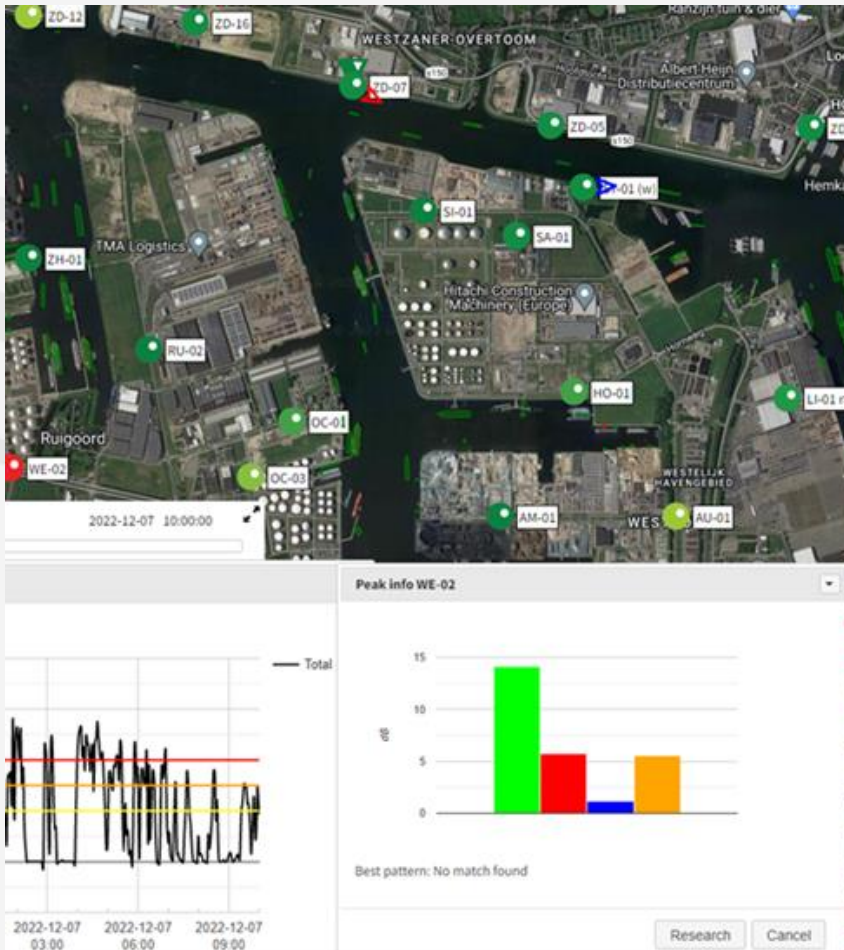
Color change of e-nose WE-02

- During 24 hours monitoring color change of e-nose WE-02 was detected.
- Wind direction checked in order to locate responsible installation.
- Information send to operator of location.
- Request for information.

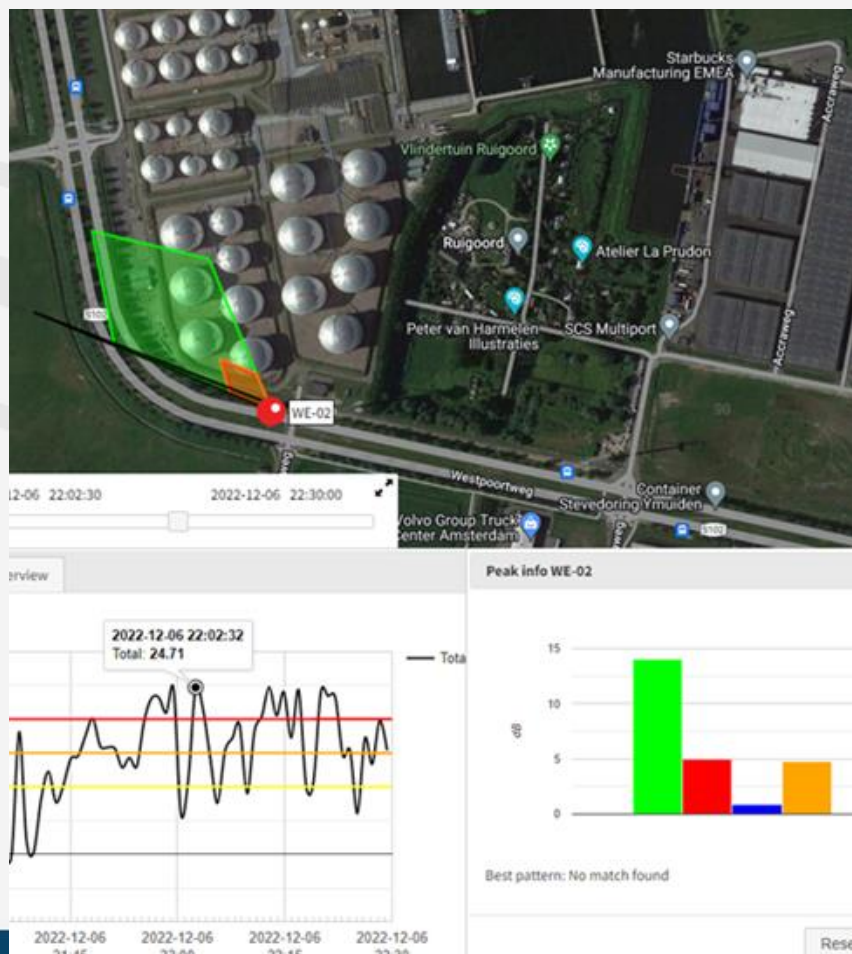
Visit on location by Inspector

- Different measurements by inspector.
- 15 minutes readings shows different peaks in emission.
- Low wind speed.
- Location of emission should be very close.
- Operator started investigation.

- During the filling of a tank, the vapor processing system was active;
- To move vapors from the tank to the vapor processing system a fan station is use;
- The fan station works automatically based on a flow control;
- The more flow is needed, the faster the fan station will run;
- The flow is controlled and measured by a flow meter;
- The flow meter has not measured any deviations in the amount of flow while the fan station was running at a (too) low speed.
- The company suspected that the flow meter is defective, as a result of which the fan station, while filling the tank, has not extracted enough vapor. As a result, vapor may have ended up above the internal floating roof through the PV valves.

- The flow control has been turned off and has been given a manual value.
As a result, the fan station extracts more vapor from the tank than can be pumped in.
- The flow meter will be repaired and/or replaced.
- The company will continue closely monitor the e-noses.

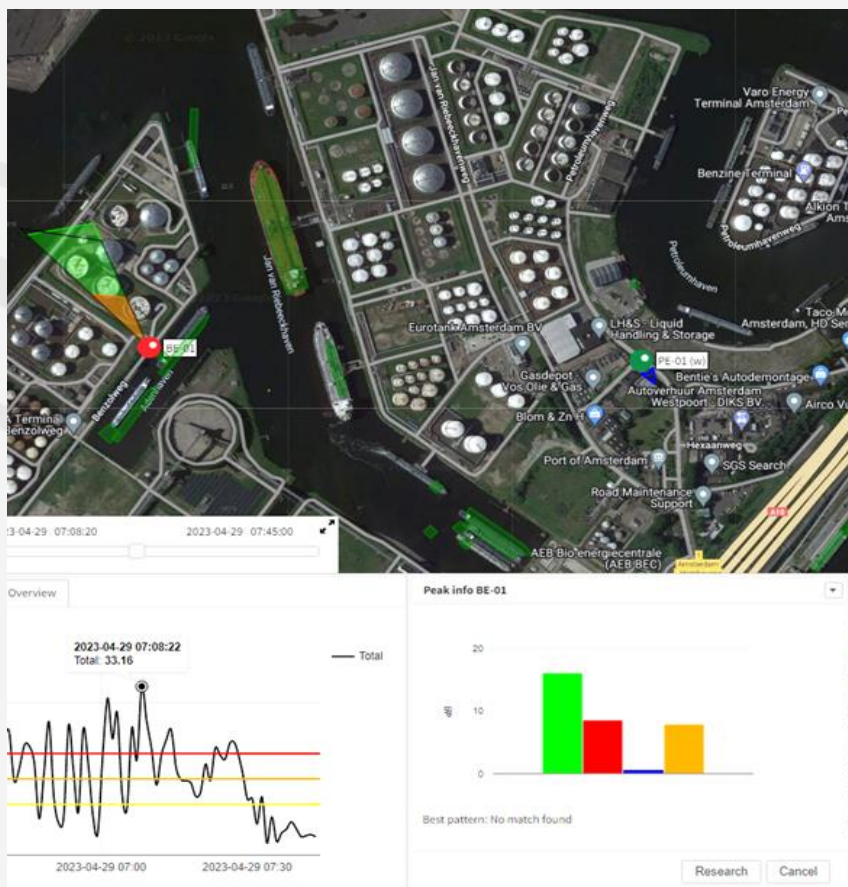
Color change of e-nose BE-01

- A very strong changes in air composition was detected.
- Moderate wind speed between 03:00 and 20:00
- Information send to operator of location.
- Request for information.

- During uploading into tank C0201 MTBE (methyl-tertiaire butylether) was also pumped from tank C0222 to tank C0203.
- Velocity aprox. 90 cbm and then the pipes were drained with MTBE to tank C0203.
- For this action, the VRU function was not active.
- The tank has an external floating roof.
- The cause of the emission was leaking seals from the floating roof.

- The VRU function must be active during drainage of pipes towards tanks.
- The operator has the obligation to check the seals more frequently.

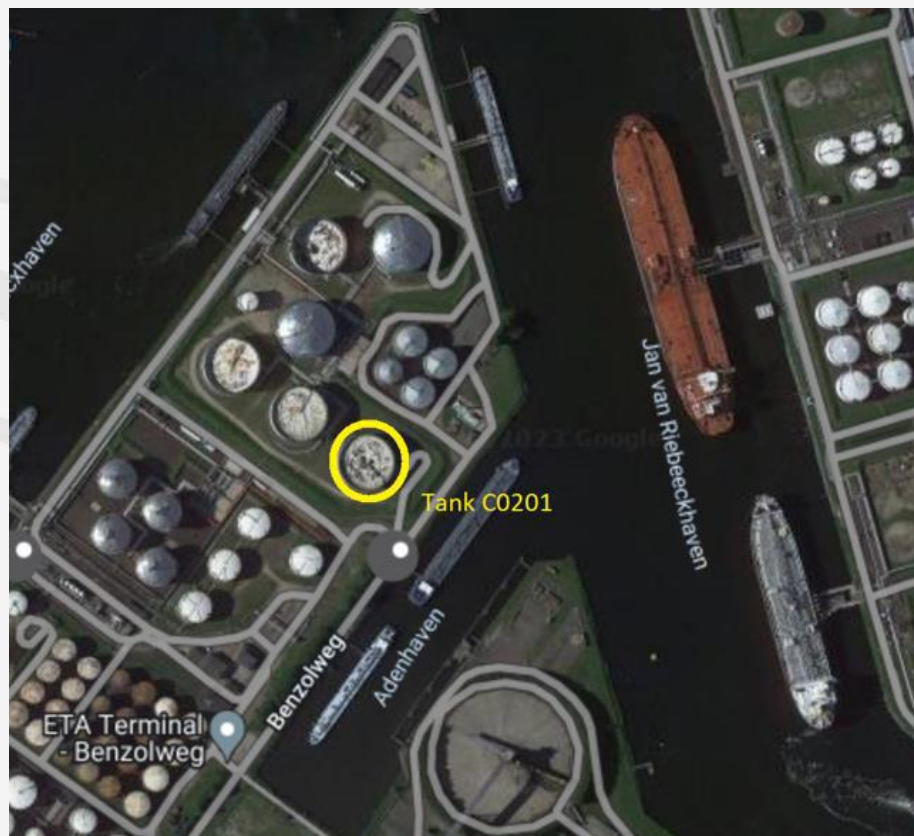
Results of investigation by operator (1)

- At the time of the observed changes in air composition, barge was unloaded from jetty 13 into tank C0201, the roof of which had landed.
- Vapors are discharged to the VRU via the VRU function.
