# Role of inspectors and overcoming challenges in applying liability legislation, case study of Croatia

Miljenka Kliček

# Case study - the installation in question

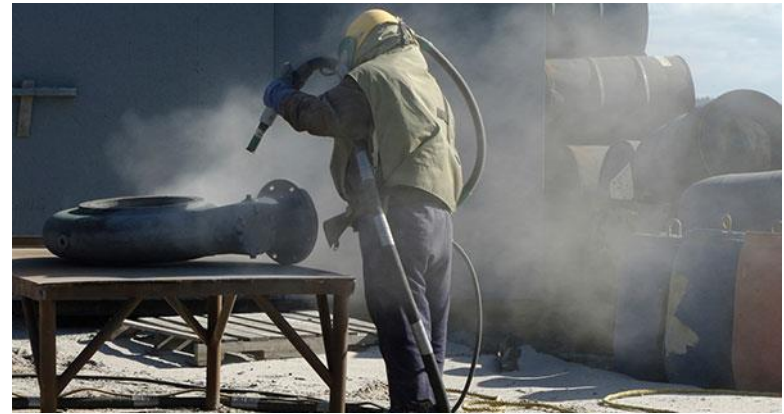
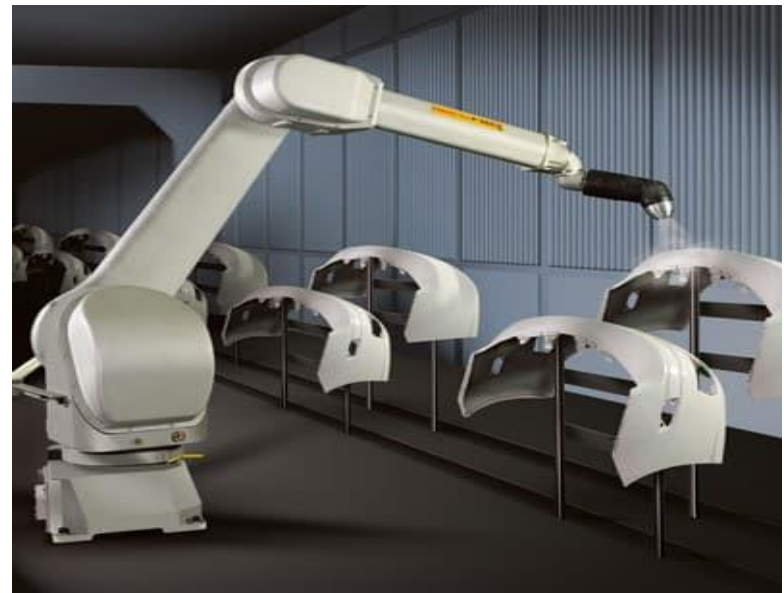
- **Metal processing company**
- **Surface treatment processes (shot blasting and spraying)**

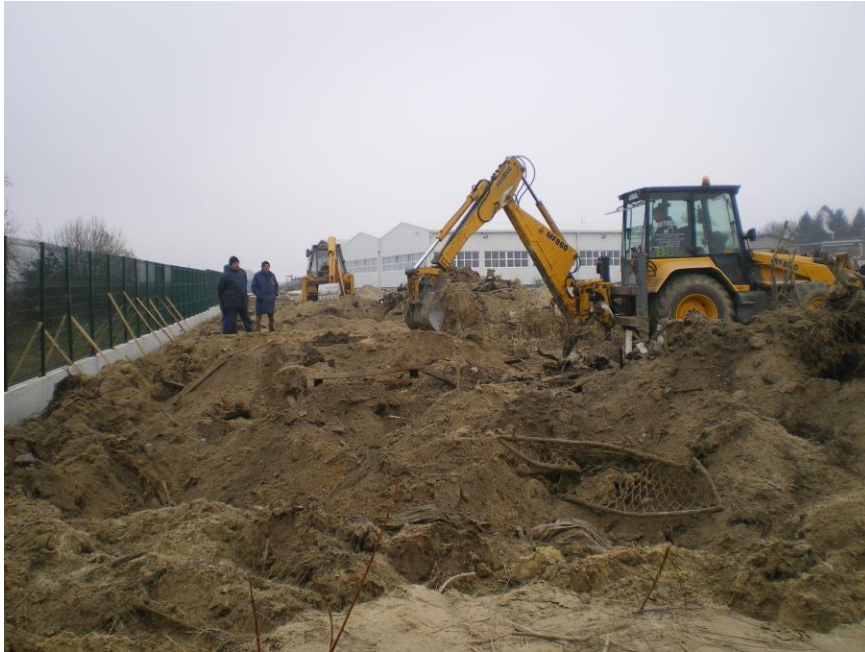
# Inspection findings

**During the routine inspection on site inspector found that construction works on new fence were going on. He noticed that some barrels were buried on site.**

**Inspector ordered the operator to dig out all buried barrels.**

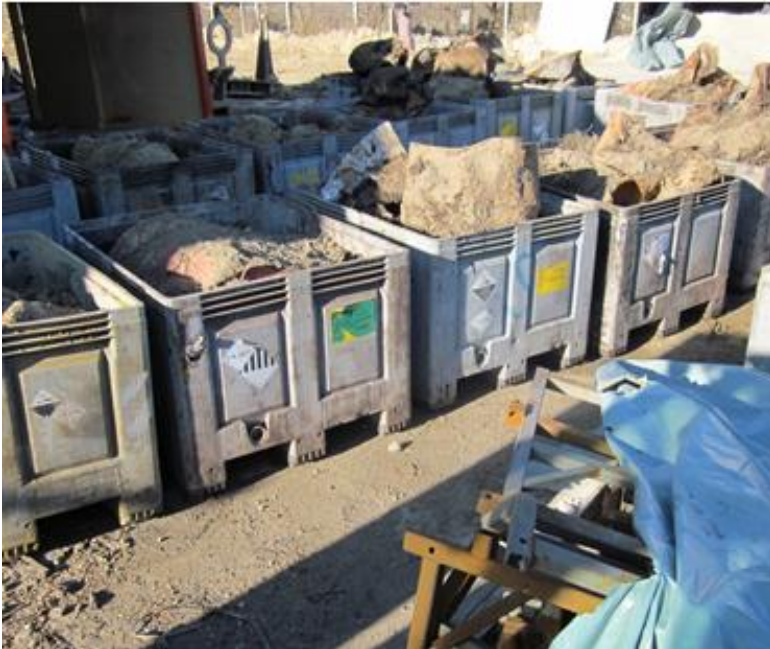
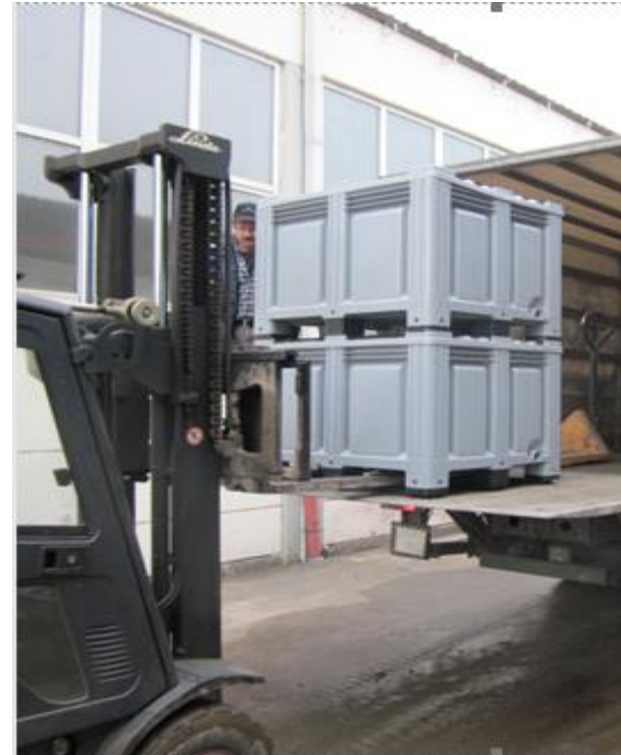
## Inspection enforcement (3)

**Operator was obliged to remove all the waste and contaminated soil and give it to the licenced company.**

## Approximately 250 m<sup>2</sup> of surface of contaminated soil

- 1. 16.750 kg of waste 08 01 11\* (waste paint and varnish containing organic solvents or other dangerous substances)*
- 2. 29.120 kg of waste 12 01 02 (ferrous metal dust and particles) – shot blasting dust*
- 3. 13.340 kg of waste 12 01 01 (ferrous metal filings and turnings)*
- 4. 28.120 kg of waste 17 05 05\* (dredging soil containing dangerous substances, outside of the fence) – contaminated soil*
