E-nose monitoring Port of Amsterdam

E-nose monitoring 2nd case

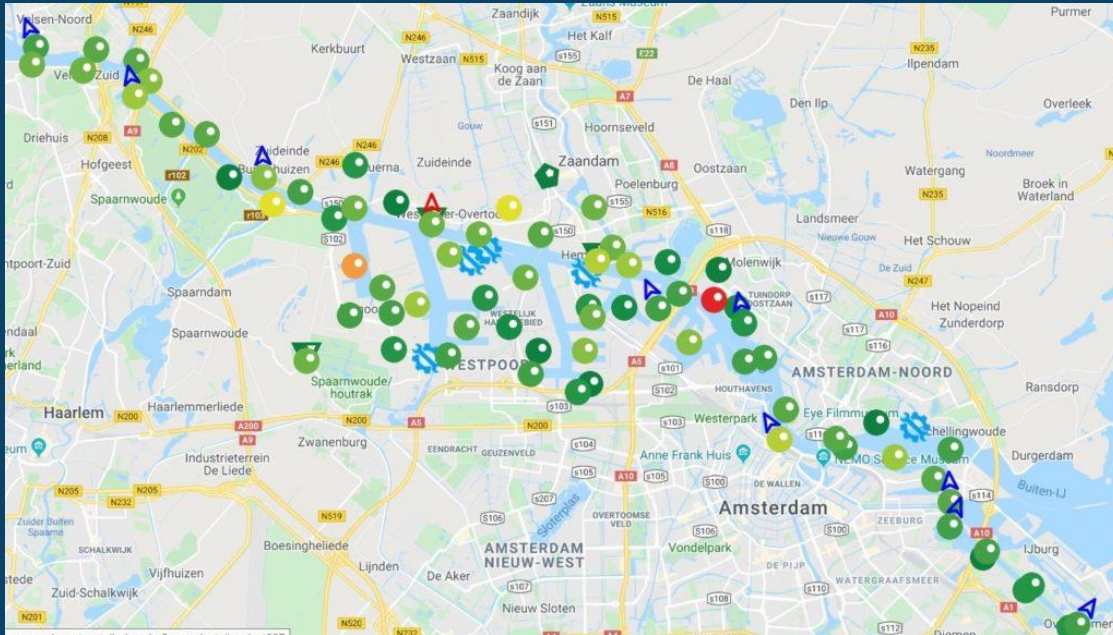
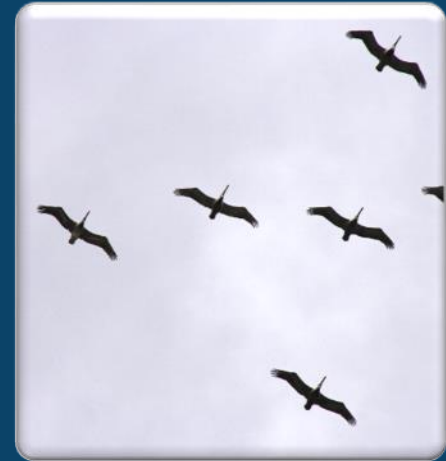
- A very strong changes in air composition was detected.
- Moderate wind speed between 03:00 and 20:00
- Information send to operator of location.
- Request for information.

- At the time of the observed changes in air composition, barge was unloaded from jetty 13 into tank C0201, the roof of which had landed.
- Vapors are discharged to the VRU via the VRU function.

- During uploading into tank C0201 MTBE (methyl-tertiaire butylether) was also pumped from tank C0222 to tank C0203.
- Velocity aprox. 90 cbm and then the pipes were drained with MTBE to tank C0203.
- For this action, the VRU function was not active.
- The tank has an external floating roof.
- The cause of the emission was leaking seals from the floating roof.
